Environmental problems of placer gold mining in the Zaamar Goldfield, Mongolia

ABSTRACT

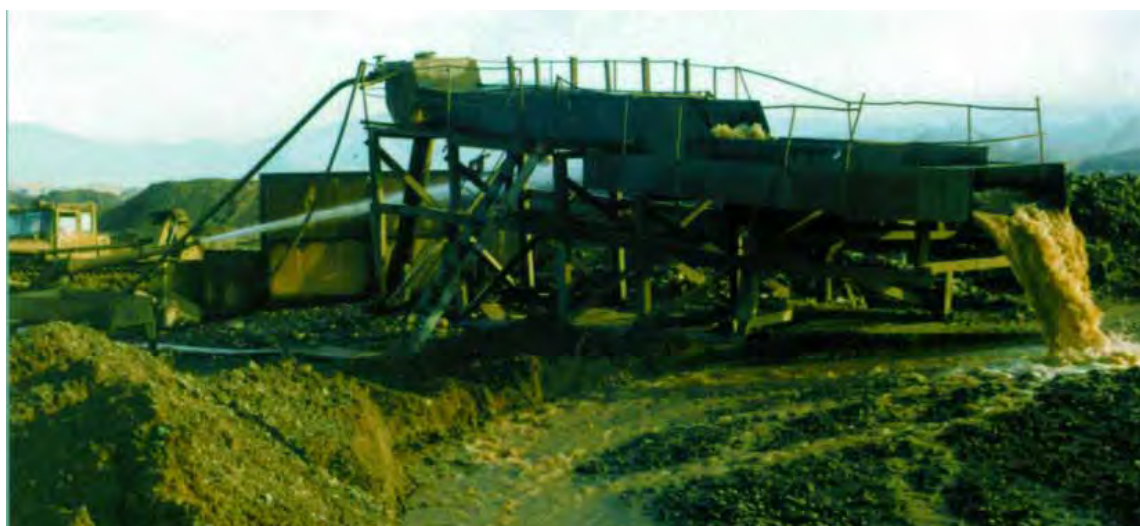
Fig.1: Typical gold recovery system in the Zaamar Goldfield, using old technology with a low % gold recovery rate and large water demand, Shijir Alt Mine of Mongolrosvestmet JSC.
(Photographer: John Farrington, August 2000).

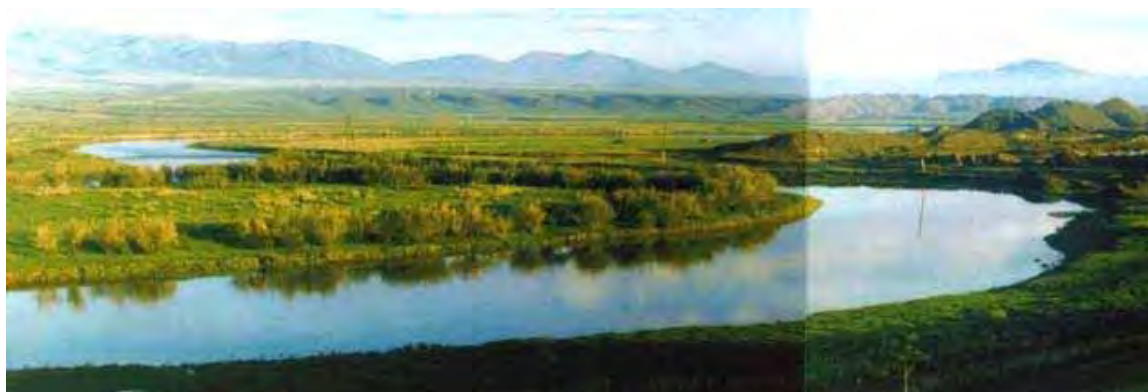
Fig.2: A relatively undisturbed section of the Tuul river, with dense willow thickets that preserve channel bank stability and provide important habitat. Note the 35m high overburden mounds to right, from draglines that eliminate scarce prime grazing lands (Photographer: John Farrington, August 2000).

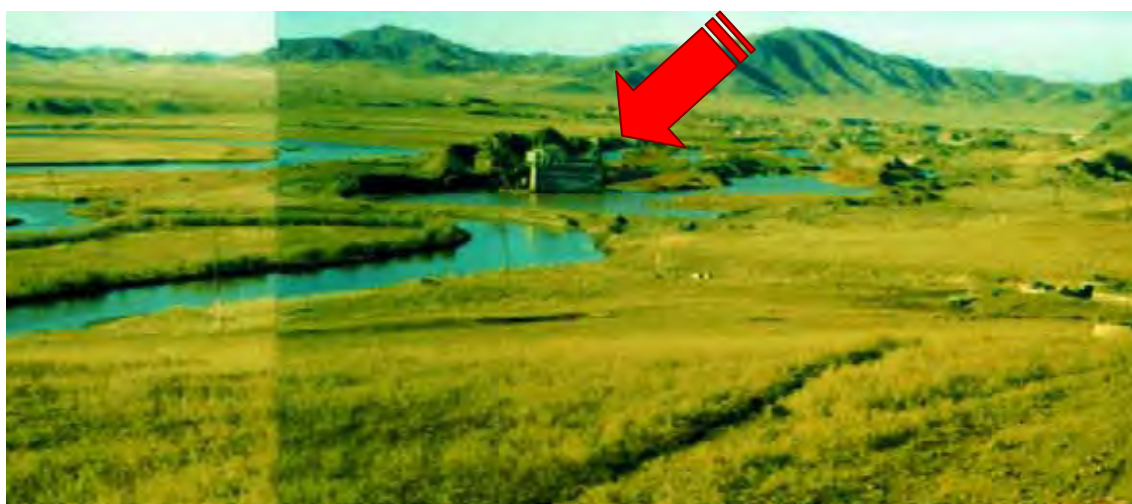
Fig.3: Large Mongolrosvestmet gold dredge, in a deep artificial dredge pond on the floodplain of the Tuul river. Note the narrow neck of land between the 7m deep dredge pond and the 1.5m deep river channel, that has a high risk of a breach by the river when in spate. Breaching of the neck would result in channel capture and the release of large volumes of silt and mud into the river. (photographer: Jeff McCusker, October 1999).

The third category of problems with settling ponds used in placer mines, and also dredge and drag-line ponds, operated in Zaamar Soum is location. The Province of British Columbia requires that all structures in a sedimentation pond system be built to withstand a 200 year flood (Ford 1997). The dikes of numerous ponds in Zaamar lie on the active river flood plain, and in one extreme case even form an artificial bank of the river (Fig.3). However, although all observed dikes on the flood plain were constructed of loose earth fill, none were rip-rapped nor in any other way reinforced to withstand fast-moving, high flood waters. When asked about flood protection measures, one mine engineer replied that it was unnecessary because the Tuul river never flooded. In the event of a flash flood, such as those that shaped the alluvial fans of the area, these earthen dikes and dams are likely to fail, resulting in the introduction of extremely large volumes of sediment into the main river channel.

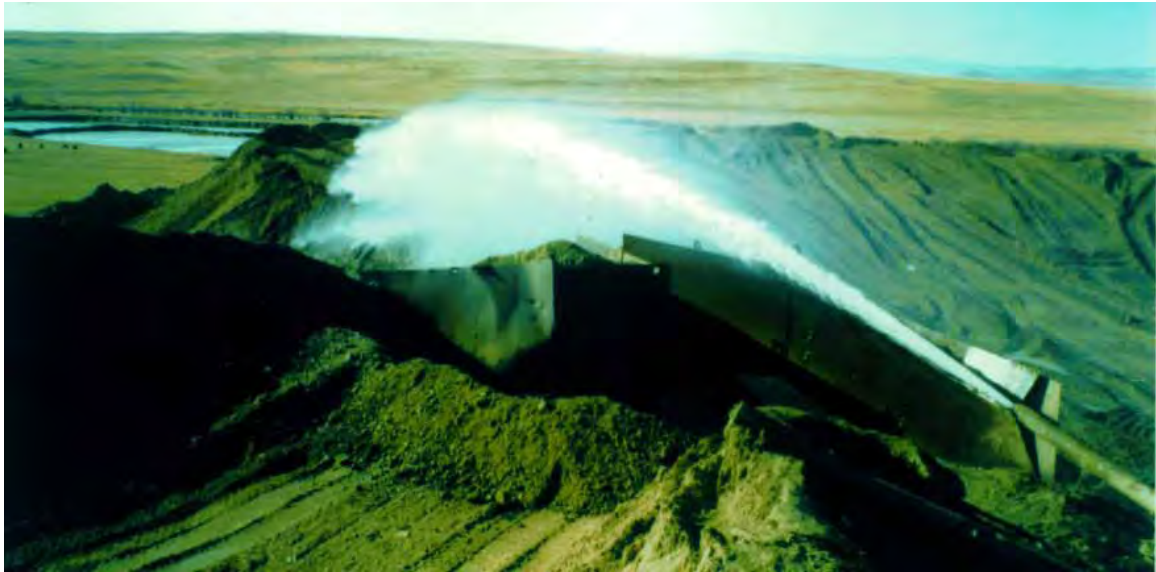
Fig.4: Poor environmental mine management at Ikh Alt Ltd., where an idle water monitor jetting water has been turned towards the tailings mounds, causing gulying and washing of sand and mud into watercourses and ponds. The water is pumped from the Tuul river. The water monitors are frequently left on for extended periods, due to the inherent difficulty of priming water pumps of traditional design when restarting them. This can be overcome by switching to water pumps of modern design. (Photographer: Jeff McCusker, October 1999).

PROBLEM	REMEDIAL ACTION
Creation of silt-laden runoff from idle wash plant jets.	Turn off pumps when jets aren't in use, or install a return pipe to the river for unused water.
Digging of open, erosion-prone ditches for water pipes.	Lay water pipes across the existing land surface.

Gravel wash plants are operated using water from pumps located on or near the banks of the Tuul river. Pump intakes are placed directly in the river, and sometimes a minor channel diversion is constructed to enhance flow to the intake. Water is pumped uphill through pipelines, sometimes up to several hundred metres in length, to wash plants where water jets are used for washing of gravels and sediment in order to gravimetrically separate gold from tailings. Because of the difficulties in priming pumps, starting pump engines, and generating enough suction head to transport water long distances, many pumps are left running continuously all day but are only used to wash sediments for a small portion of that time. Idle jets are typically pointed at tailing piles beside wash plants where the freshly pumped "clean" river water erodes the tailing pile, picking up a large suspended sediment load. The water then flows to settling ponds, unnecessarily filling the pond with water and sediment, or returns directly to the river as newly silt laden water, never actually having been used in the mining process (Figs. 4 & 5). One solution to this extremely wasteful practice would be to simply turn off the pump for the long hours when the jet may be idle, or if this is problematic, a return pipe should be installed to deliver the unused water to the river clean.

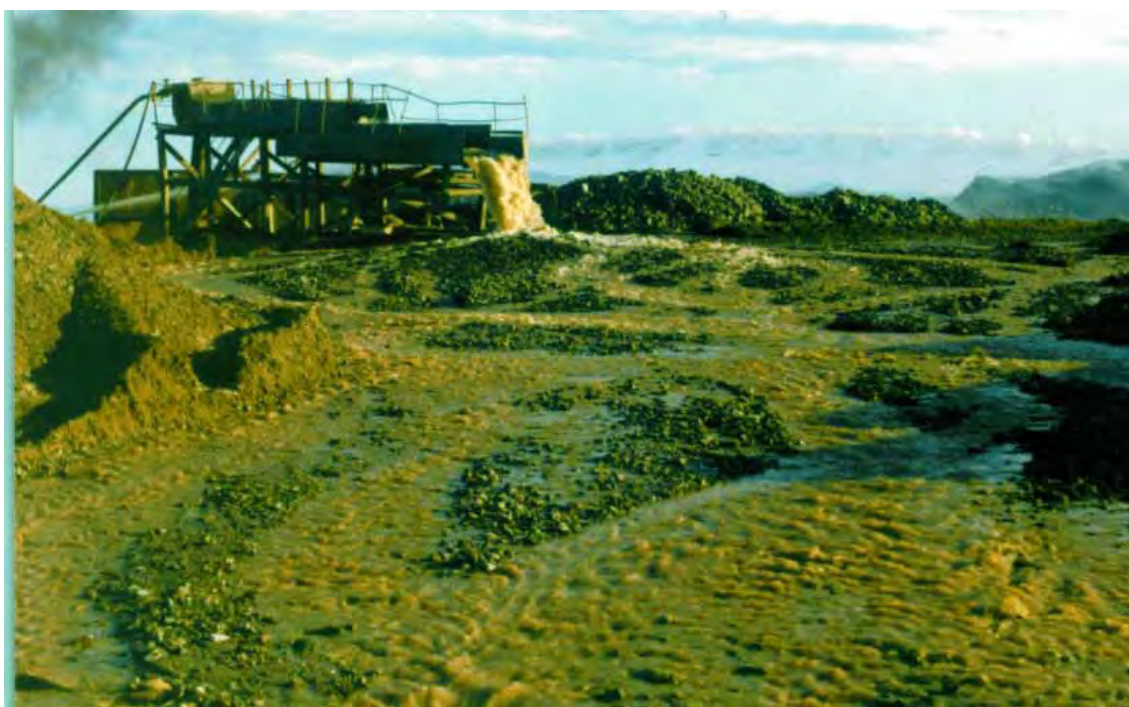
Fig.6: Example of inefficient technology, a traditional style sluice that is incapable of recovering fine gold, and requires excessive use of water, which rapidly fills settling ponds with sediment, and causes inadequately treated waste-water to overflow in an uncontrolled manner due to the large volumes of water used. (Photographer: John Farrington, August 2000).

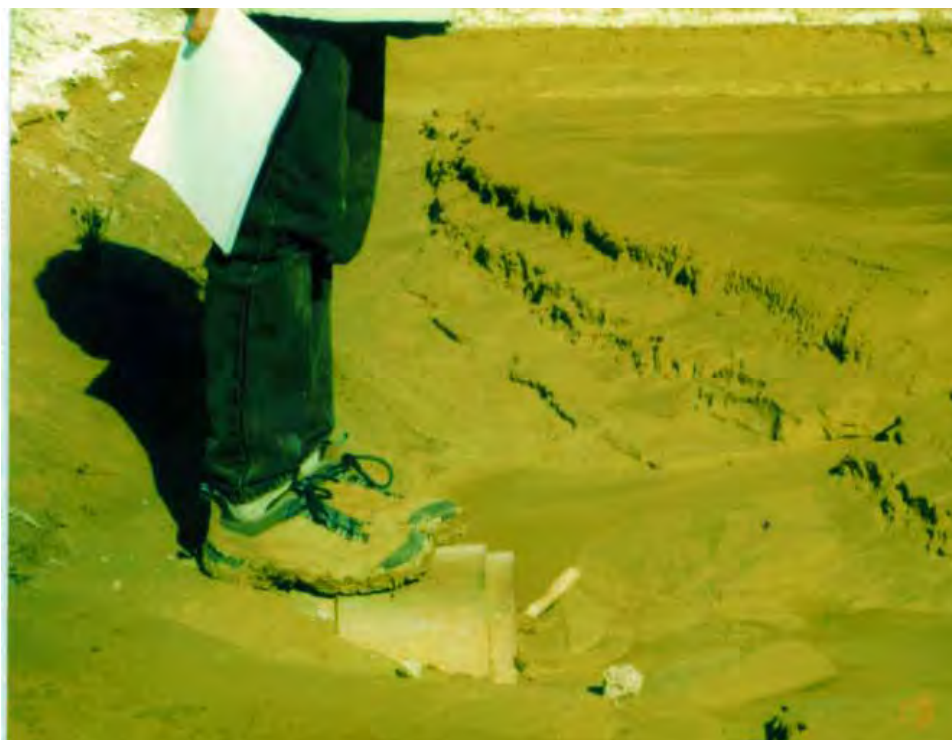
Fig.7: Example of bad environmental mine management at Tomin Co. Ltd. gold mine, with settling pond allowed to become completely choked with sediment, including the outlet pipe, allowing mine waste sediment to escape directly into the Tuul river. (Photographer: Jeff McCusker, October 1999).

The second category of problems with settling ponds used in Zaamar's placer mines is improper operation. Site visits were made late in the season, and many ponds observed were nearly or completely filled with sediment, and in one case even the final outflow pipe of a pond was over half filled with sediment (Fig.7). Settling ponds completely full of sediment quickly develop stream channels through the soft sediments, eroding them, and leaving the ponds with residence times measured in minutes, not in terms of the multiple days required for fine silt and suspended sediment removal. In order for settling ponds to operate properly, they must be of sufficient depth and must have that depth maintained by frequent removal of deposited sediments.

Both the Province of British Columbia and the State of Montana require that ponds have **MINIMUM POND LIQUID DEPTHS OF 1.5 m**, and that ponds never be more than 50% full of sediment. British Columbia requires a half metre of freeboard and implementation of stringent pond dike design safety criteria, while the State of Montana requires 1.25 metres of freeboard, and recommends that ponds be dug into the ground to enhance percolation (McCulloch 1993, Ford 1997). In Zaamar Soum, some ponds were observed to be completely full in late August, and were operated in such a condition for at least the final 2 months of the mining season, but probably longer. In order to maintain a minimum liquid depth of 1.5 metres, ponds must be cleaned of sediment on a daily to weekly basis. Removed silt and fine sediments are a valuable reclamation resource in themselves, and should be stockpiled and protected from rain erosion for later placement beneath restored topsoil layers.

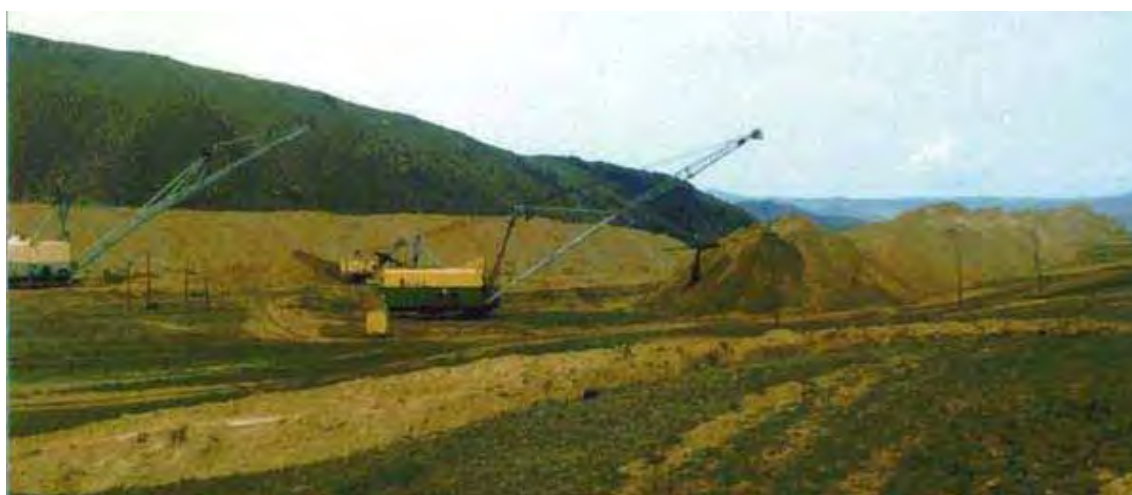
Fig.8: Two drag lines active in the Hailaast Valley, a minor tributary of the Tuul river. Note steep-sided mounds of overburden dumped close to hillside on left. (Photographer: John Farrington, August 2000).

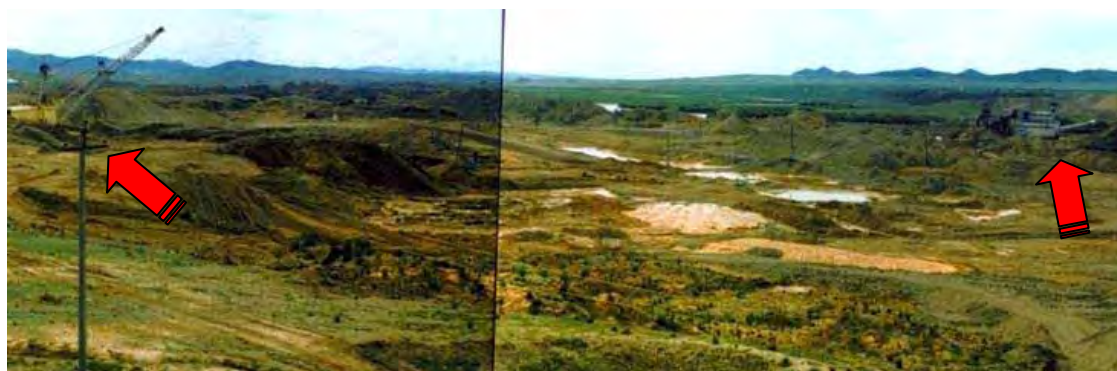
Fig.25: As yet unreclaimed stretch of Tuul river floodplain, severely damaged by dragline (left) and dredge (right). Note that the active river channel is barely visible behind the overburden mounds (Photographer: John Farrington, August 2000).

1. the use of heavy earth moving equipment to extract and load material onto dump trucks for transportation to washing plants;
2. the use of draglines to extract sediments from water filled mine pits dug below the groundwater table (Figs.8 & 25);
3. in one case, the use of a 4-storey high river dredge and washing plant which floats on an artificial pond dug into the Tuul river's active flood plain (Figs. 3 & 25).
